Vibration Issues

Typical Causes for Gas
& Steam Turbines

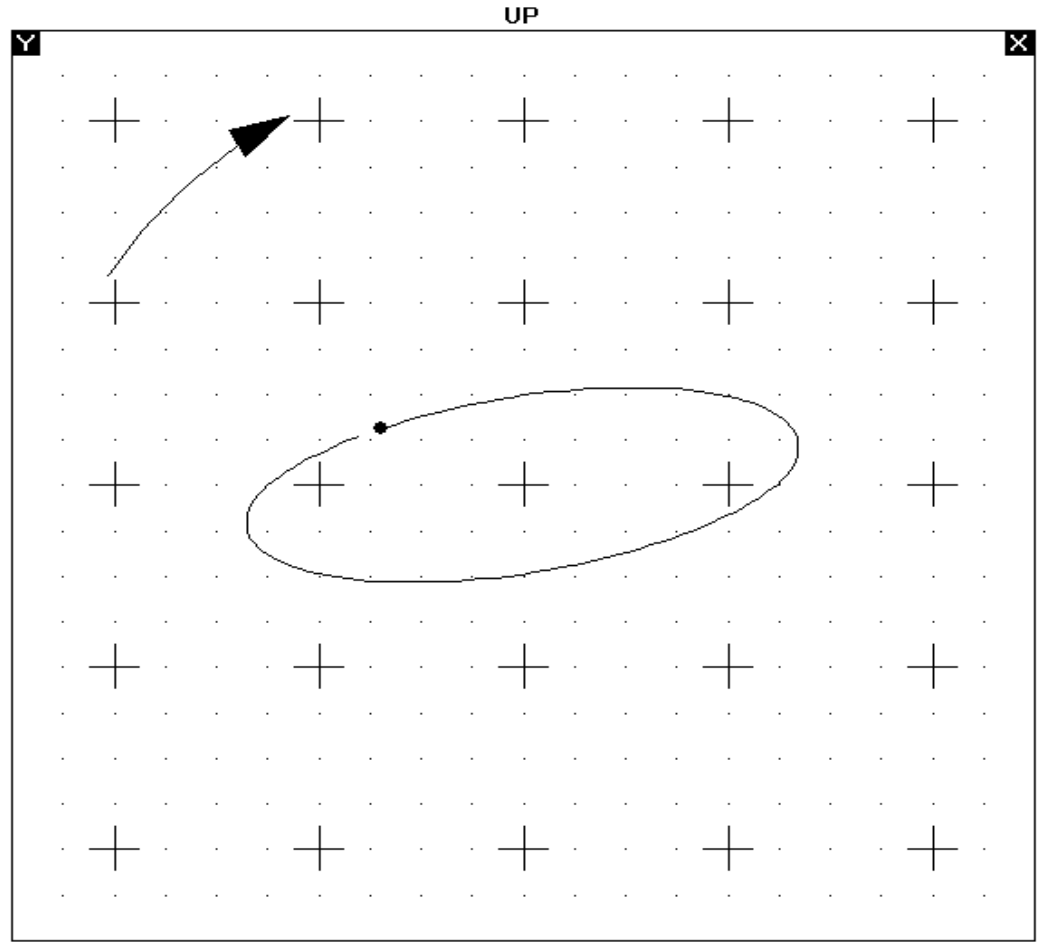
Y: #2 Turb Brg - TIE $\angle 45^\circ$ Left VECTOR: 3.52 mil pp $\angle 327^\circ$
X: #2 Turb Brg - TIE $\angle 45^\circ$ Right VECTOR: 4.66 mil pp $\angle 106^\circ$
MACHINE: Unit 2
26MAR2002 13:53:55.7 Startup 1X UNCOMP

ROTATION: Y TO X [CW]

5360 rpm

- Remember – good/complete set of data is vital to analyzing the cause of the vibration
 - Take data at the bearing caps
 - Vertical
 - Horizontal
 - Axial
 - Take data at shaft
 - Units equipped with X&Y Bentley Nevada probes provide sufficient data

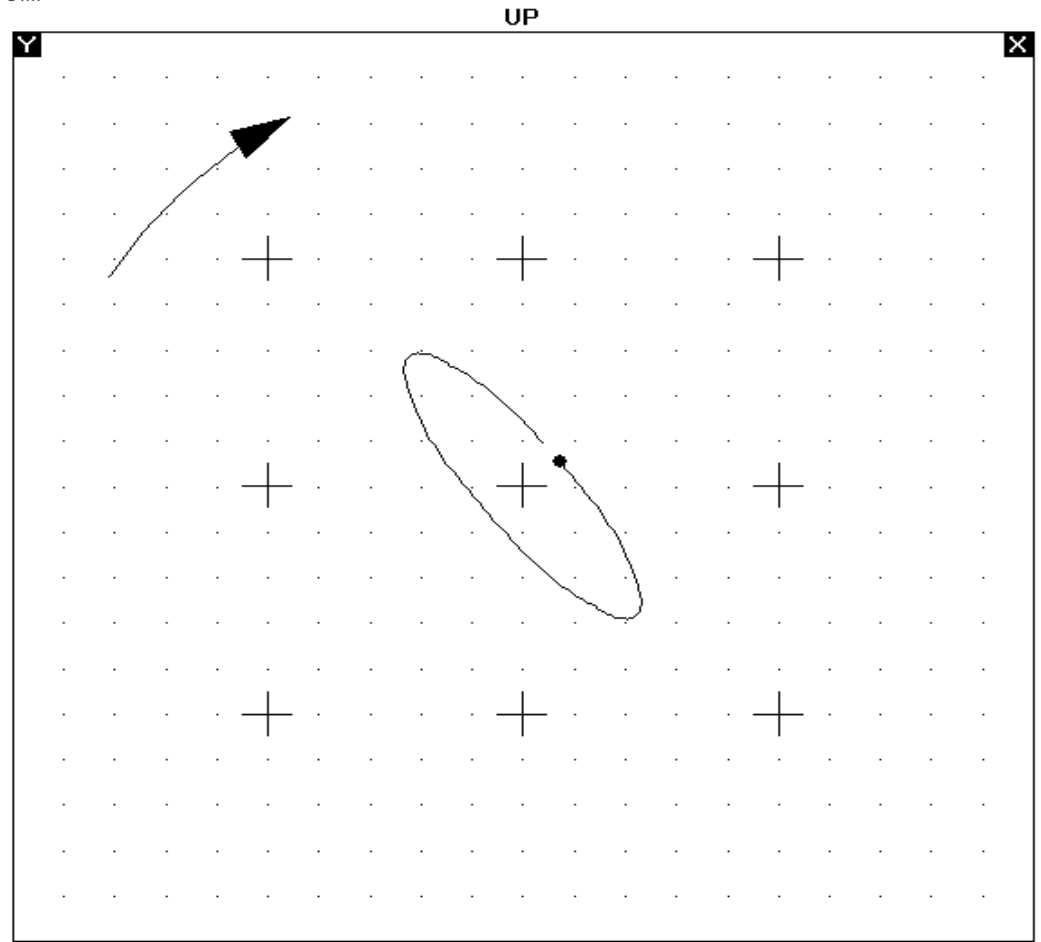
Y: #2 Turb Brg - X $\angle 45^\circ$ Left VECTOR: 0.720 mil pp $\angle 270^\circ$
X: #2 Turb Brg - Y $\angle 45^\circ$ Right VECTOR: 0.206 mil pp $\angle 336^\circ$
MACHINE: Steam Turbine
18APR2002 08:41:53.0 Startup 1X UNCOMP

0.1 mil /div

ROTATION: Y TO X [CW]

3240 rpm

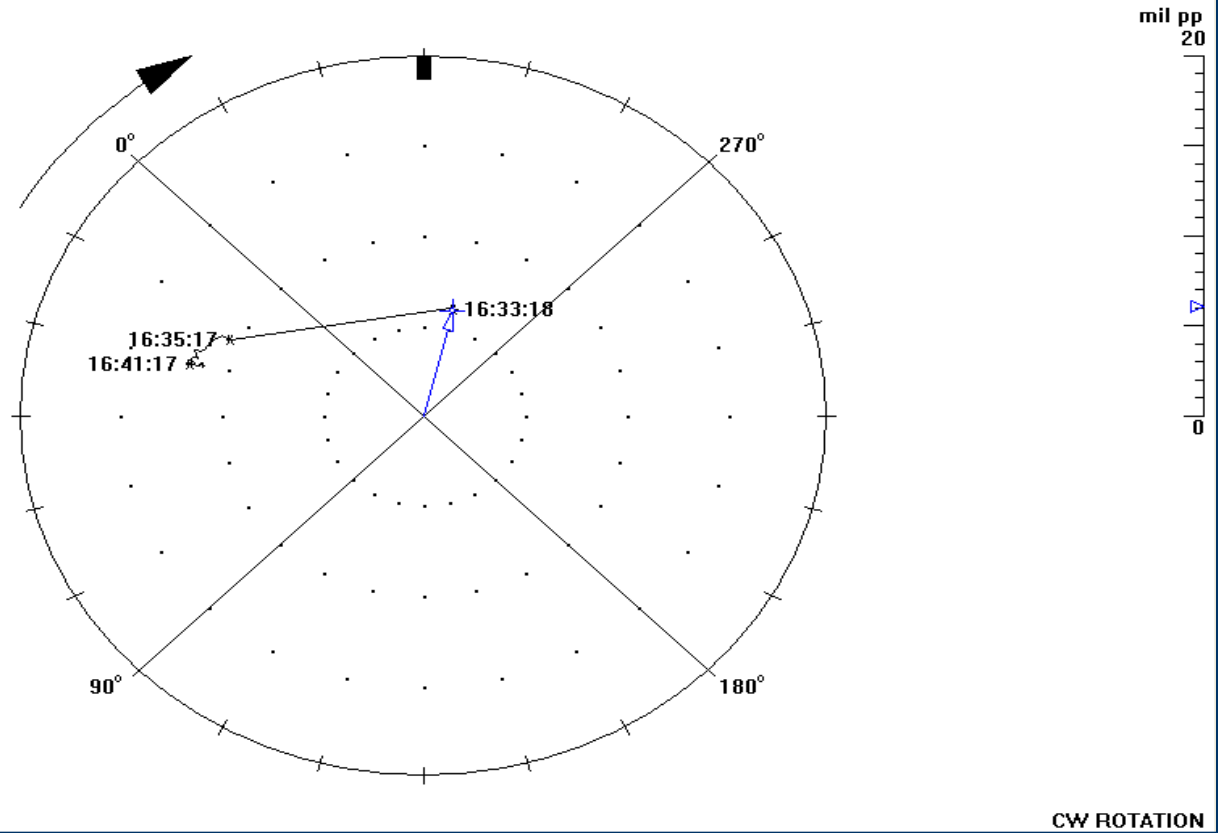
POINT: GEN SHAFT GEAR END /45° Left 1X UNCOMP 6.02/301° @16:33:47
MACHINE: S/N 8383422
From 07DEC1993 16:33:18.4 To 07DEC1993 16:45:47.6 Steady State

Severe case of shorted turns - as soon as unit is synchronized, vibration jumps over 10 mils

- Caused by shorted turns in the rotor, causing hot spots
- Vibration levels will vary with load
 - in some cases load limiting

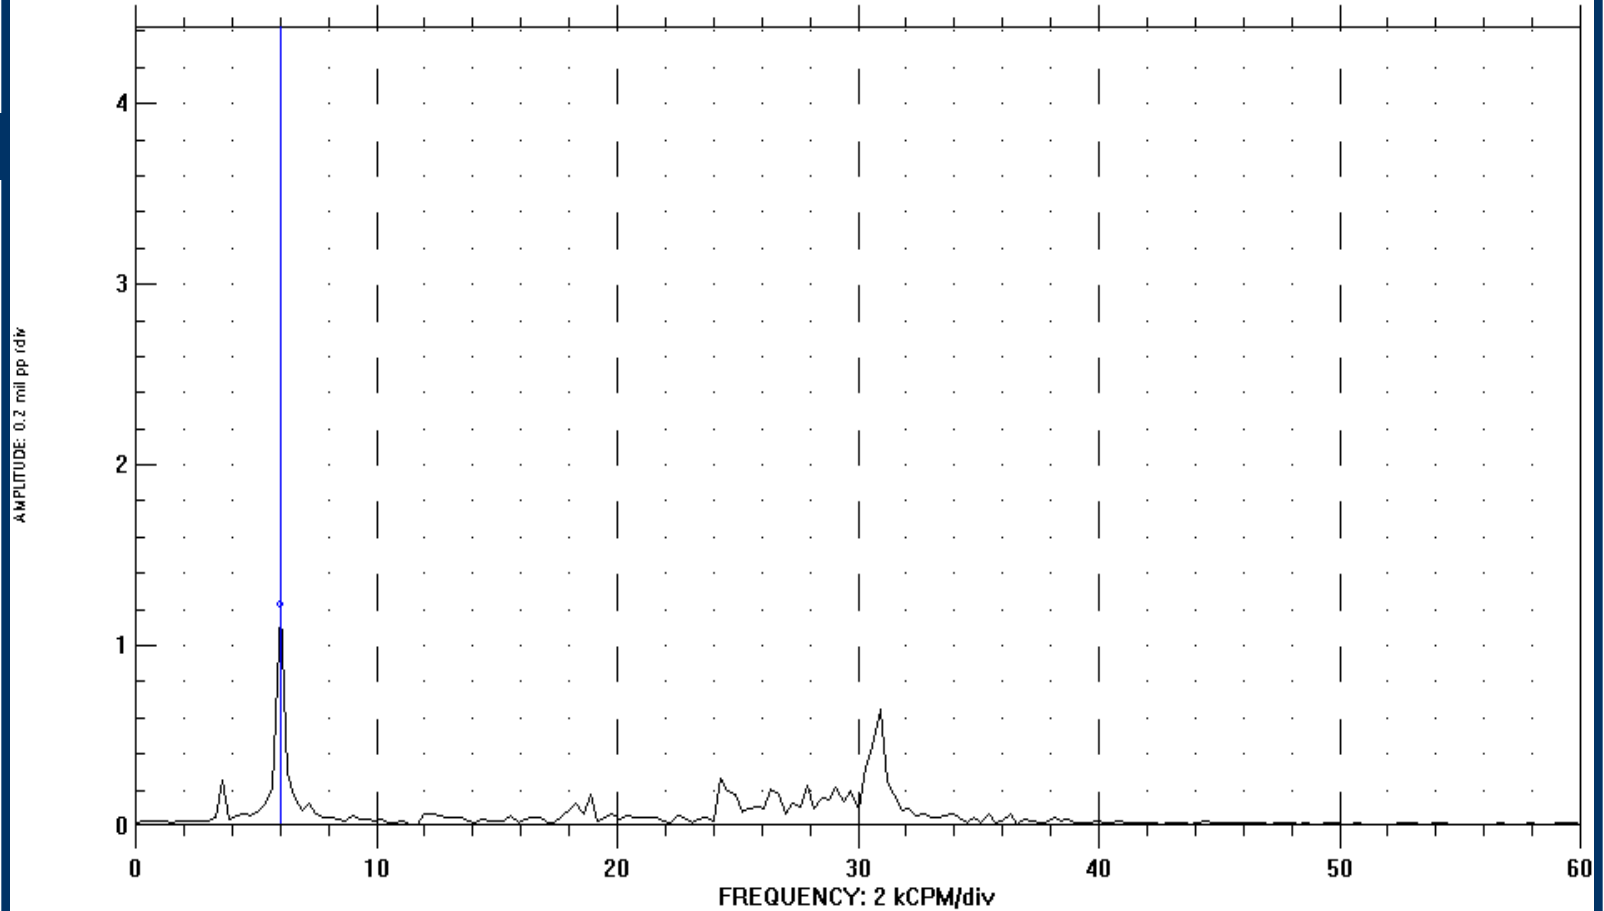
POINT: Access Gear Vert $\angle 0^\circ$ DIR AMPL: 3.34 mil pp
MACHINE: Unit 10 MACHINE SPEED: 3602 rpm
10 JUN 2003 13:46:13.1 Startup
WINDOW: None SPECTRAL LINES: 200 RESOLUTION: 300 CPM

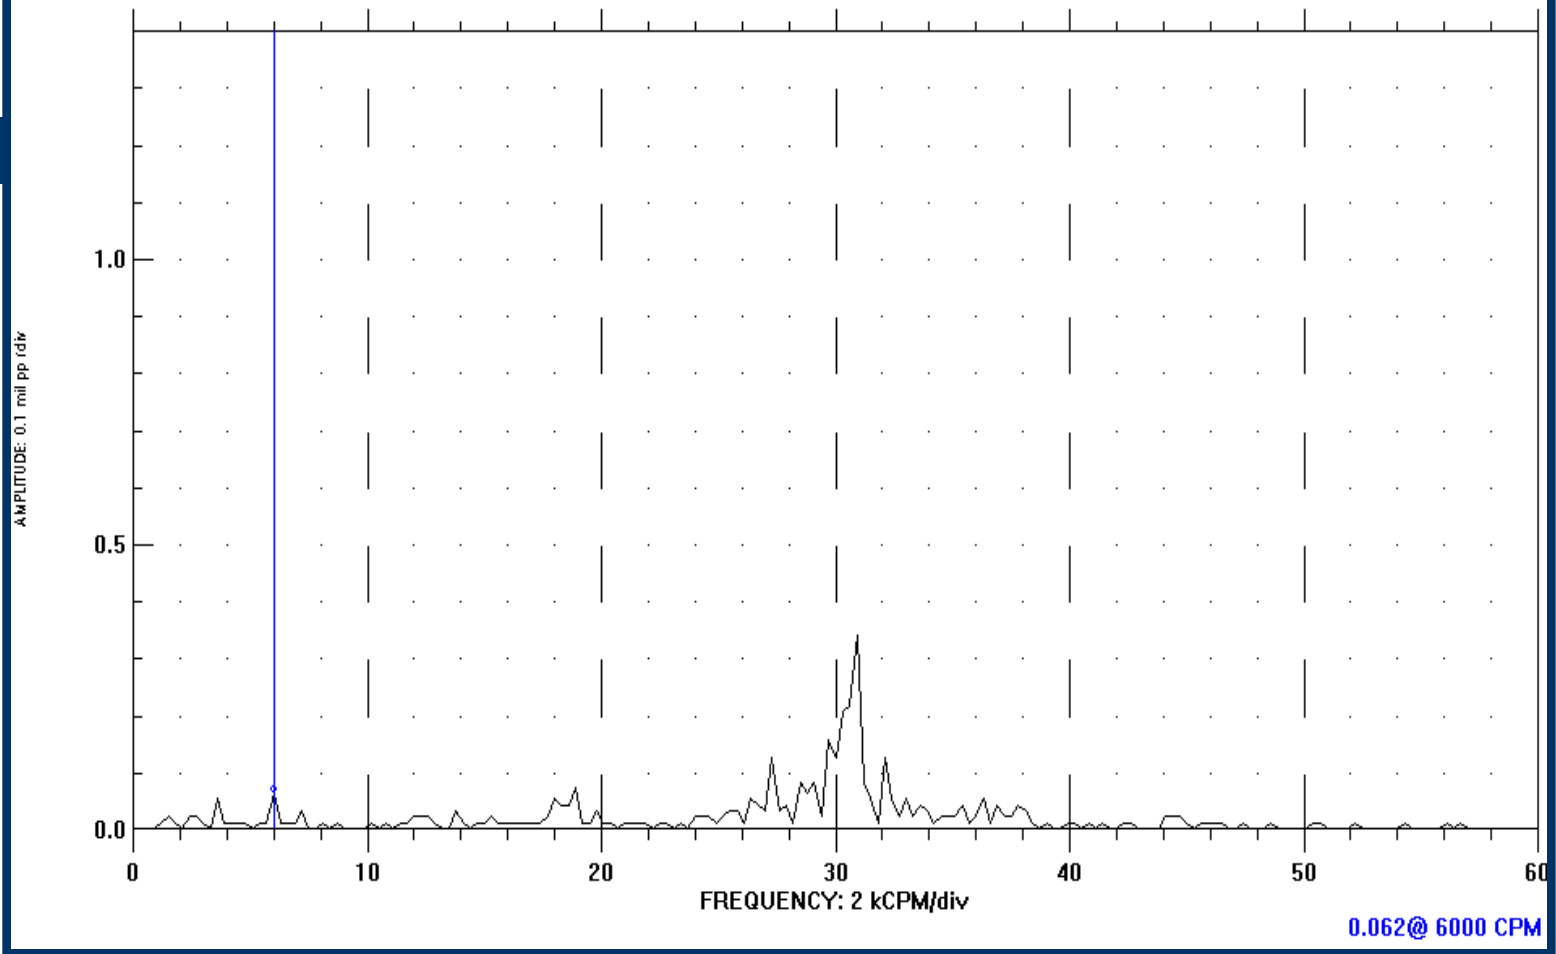
POINT: Access Gear Horiz /90° Right DIR AMPL: 1.10 mil pp
MACHINE: Unit 10 MACHINE SPEED: 3604 rpm
13 JUN 2003 16:57:57.1 Startup
WINDOW: None SPECTRAL LINES: 200 RESOLUTION: 300 CPM

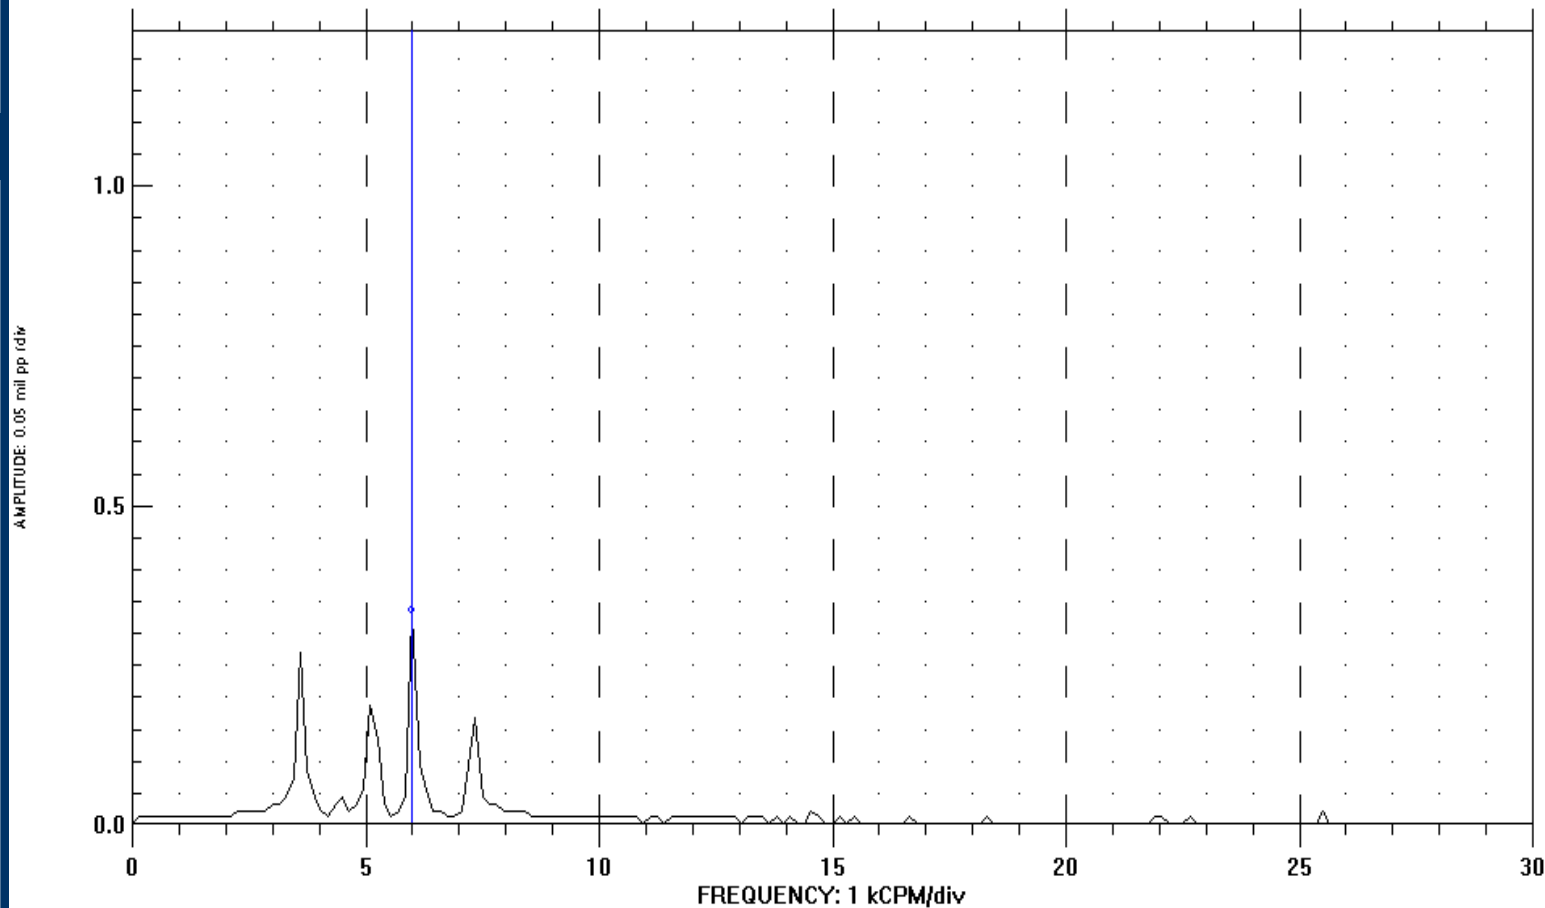
POINT: Pedestal Axial $\angle 0^\circ$ DIR AMPL: 0.735 mil pp
MACHINE: Unit 2b MACHINE SPEED: 3644 rpm
17 JUL 2002 15:52:13.1 Startup
WINDOW: None SPECTRAL LINES: 200 RESOLUTION: 150 CPM
